**DEPARTMENT OF TRANSPORTATION**

Contract #: 04-0120F4Cty: SF/ALA Rte: 80 PM: 13.2/13.9File #: 1.28**WELDING INSPECTION REPORT****Resident Engineer:** Casey, William**Address:** 333 Burma Road**City:** Oakland, CA 94607**Report No:** WIR-028137**Date Inspected:** 09-Aug-2012**Project Name:** SAS Superstructure**OSM Arrival Time:** 700**Prime Contractor:** American Bridge/Fluor Enterprises, a JV**OSM Departure Time:** 1930**Contractor:** American Bridge/Fluor Enterprises, a JV**Location:** Job Site**CWI Name:** Julian Razo**CWI Present:** Yes No**Inspected CWI report:** Yes No N/A**Rod Oven in Use:** Yes No N/A**Electrode to specification:** Yes No N/A**Weld Procedures Followed:** Yes No N/A**Qualified Welders:** Yes No N/A**Verified Joint Fit-up:** Yes No N/A**Approved Drawings:** Yes No N/A**Approved WPS:** Yes No N/A**Delayed / Cancelled:** Yes No N/A**Bridge No:** 34-0006**Component:** SAS OBG**Summary of Items Observed:**

Caltrans Office of Structural Material (OSM) Quality Assurance Inspector (QAI) Joselito Lizardo was present at the Self Anchored Suspension (SAS) job site as requested to perform observations on the welding of components for the San Francisco Oakland Bay Bri

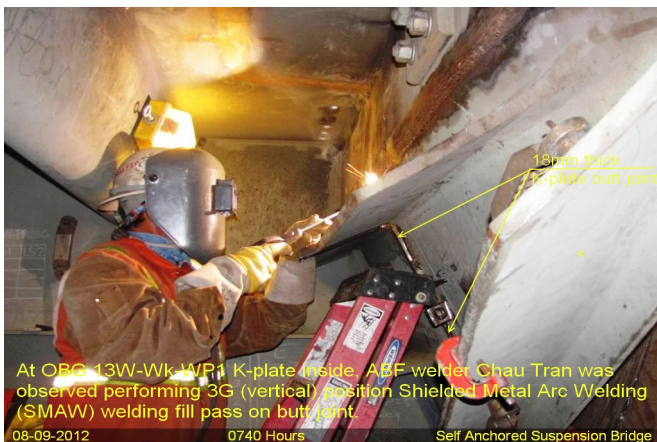
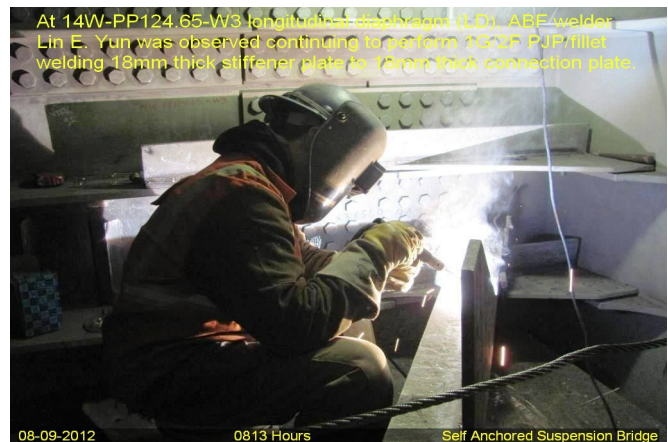
At OBG 13W-PP122.2-LS1 deck stiffener flange inside, QA randomly observed ABF/JV qualified welder Jose Torres continuing to perform PJP groove welding root pass to fill pass on the deck stiffener flange T-joint. The welder was observed perform manual welding in the 4G (overhead) position utilizing a Shielded Metal Arc Welding (SMAW) with 3.2mm diameter E9018H4R electrode and implementing Caltrans approved Welding Procedure Specification (WPS) ABF-WPS-D15-1162-4. The stiffener flange plate has a bevel groove being welded PJP T-joint to the longitudinal stiffener. The plates were preheated to more than 200 degree Fahrenheit using Miller Proheat 35 Induction Heating System. During welding, ABF Quality Control (QC) Julian Razo was noted monitoring the welding parameters of the welder with measured working current of 125 amperes on the 3.2mm E9018H4R. During the shift, cover pass welding was completed and the welder held the same preheat of >200 degree Fahrenheit for three hours after welding as required.

observed ABF welder Lin E. Yun perform Partial Joint Penetration (PJP) welding on 18mm thick stiffener plate to 18mm thick connection plate. The welder was noted welding in 1G (flat) position and fillet welding using Shielded Metal Arc Welding (SMAW) with 3.2mm diameter E7018 H4R electrode implementing Welding Procedure Specification (WPS) ABF-WPS -D15-1160 and ABF-WPS-D15-F1200A. The horizontal stiffener being welded to the connection plate has a 45° bevel that is T-joint connected to the multiple drilled holes connection plate. The fit up was previously checked by ABF QC Julian Razo and randomly verified by this QA. During welding, the welder was noted preheating the plates to more than 150°F using propylene gas torch prior welding. ABF QC Julian Razo was noted monitoring the welding parameters with measured working current of 125 amperes during welding. During the shift, PJP on one side and fillet welding on the other side on four connection plate stiffeners were completed.

At OBG 13W-WK-WP1 K-plate inside, QA randomly observed ABF/JV qualified welder Chau Tran continuing to perform CJP groove welding fill pass on the K plate butt joint. The welder was noted manual welding in the 3G (vertical) position utilizing a Shielded Metal Arc Welding (SMAW) with 3.2mm diameter E7018H4R electrode and implementing Caltrans approved Welding Procedure Specification (WPS) ABF-WPS-D15-1040C Rev.1. The plates were preheated to more than 150 degree Fahrenheit using propylene gas torch prior welding. During welding, ABF Quality Control (QC) Julian Razo was noted monitoring the welding parameters of the welder with measured working current of 123 amperes. At the end of the shift, fill pass welding was still continuing and should remain tomorrow.

At OBG 13W-PP121.6 plate 'G' inside, QA randomly observed ABF/JV qualified welder Mike Jimenez perform root pass to fill pass welding on the Complete Joint Penetration (CJP) splice butt joint. The welder was observed manually welding in the 3G (vertical) position utilizing a Shielded Metal Arc Welding (SMAW) with 1/8"

diameter E7018H4R electrode and implementing Caltrans approved Welding Procedure Specification (WPS) ABF-WPS-D15-1040A Rev.1. The joint being welded has a single V-groove butt joint with ceramic backing bar that will be removed and back gouged. ABF QC Julian Razo performed the fit up check and noted 1mm misalignment and 13mm root opening. This QA verified the fit up and noted the same. During the shift, the welder has completed the root pass to cover pass on one side then moved underneath and removed the ceramic backing then performed back gouging using carbon air arc gouging. ABF QC Julian Razo was noted performing Magnetic Particle Testing (MT) on the back gouged and smoothly ground the surface with no relevant indication noted. The welder resumed welding the splice butt joint at overhead position until the end of the shift.
